Summary of HCAT Helicopter Dynamic Components Project

Keith Legg
Rowan Technology Group
Libertyville, IL

13. SUPPLEMENTARY NOTES Surface Finishing and Repair Issues for Sustaining New Military Aircraft Workshop, February 26-28, 2008, Tempe, AZ. Sponsored by SERDP/ESTCP.

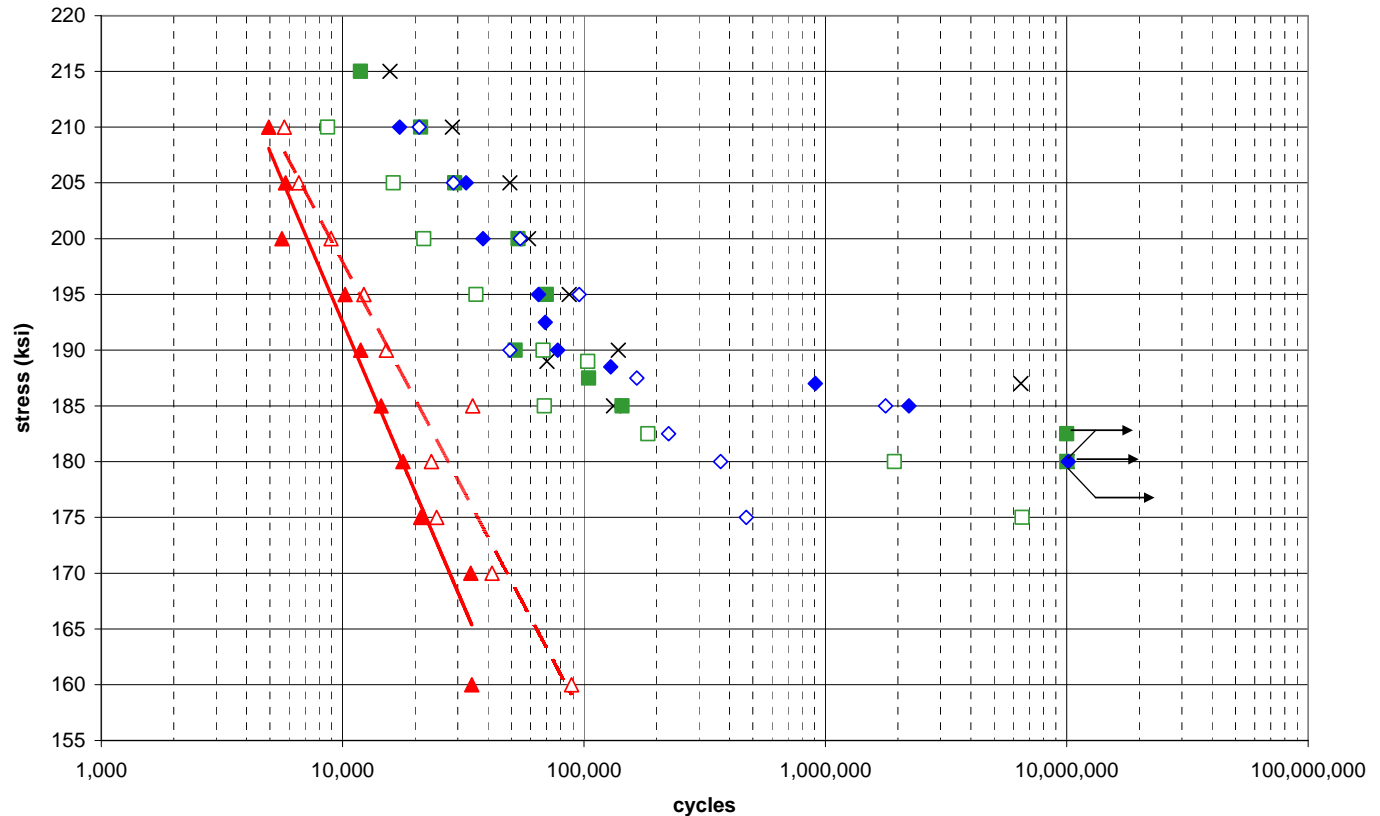
2360-83163 Fatigue Data
Room Temp, R = 0.1, 9310 (steel)

Usually thicker coatings give more fatigue

Here thicker is better

Presumably carrying load

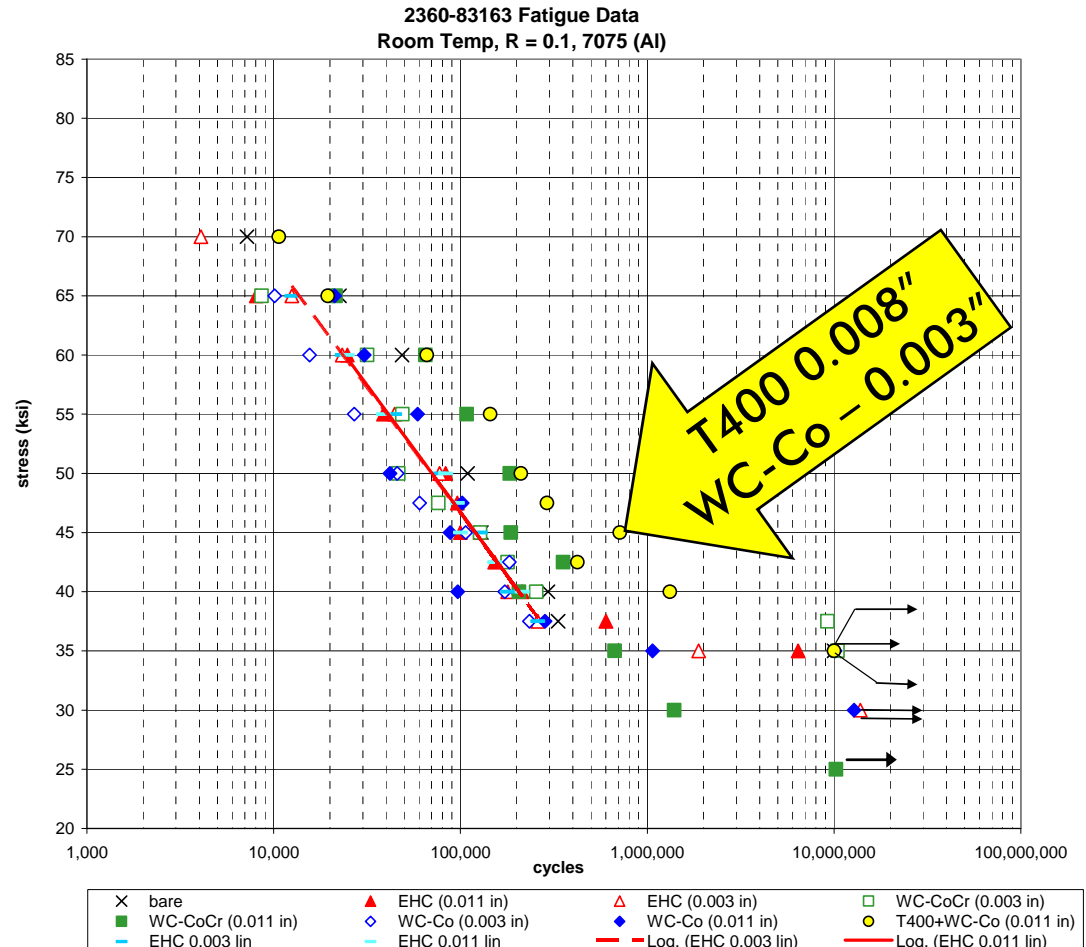
Fatigue of 7075 Al

In the past HVOF carbides gave fatigue worse than EHC

Here WC-CoCr is better and duplex coating is a lot better
Better modulus match

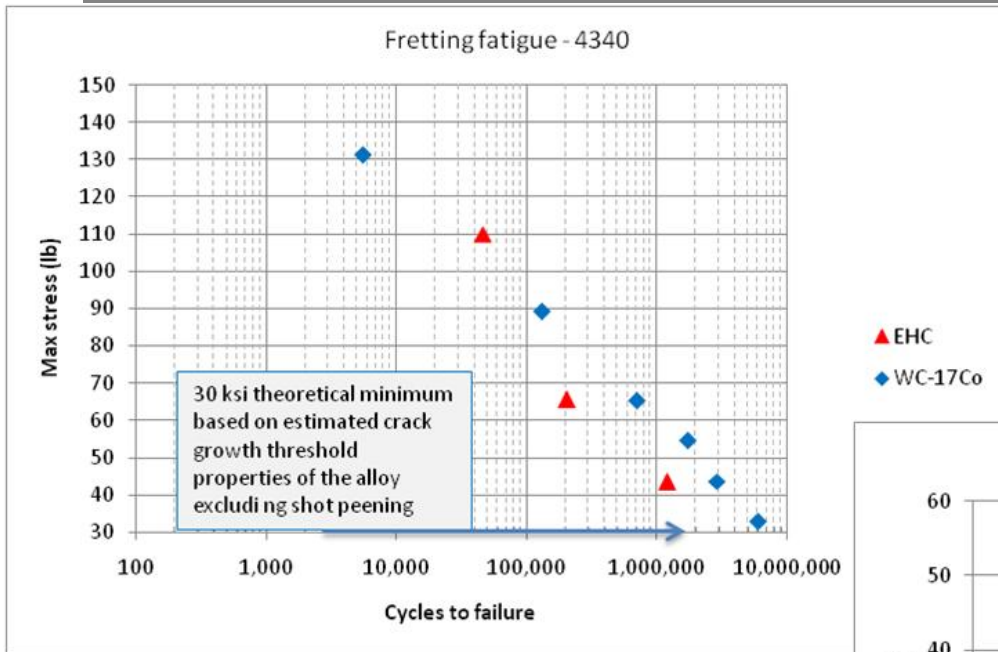
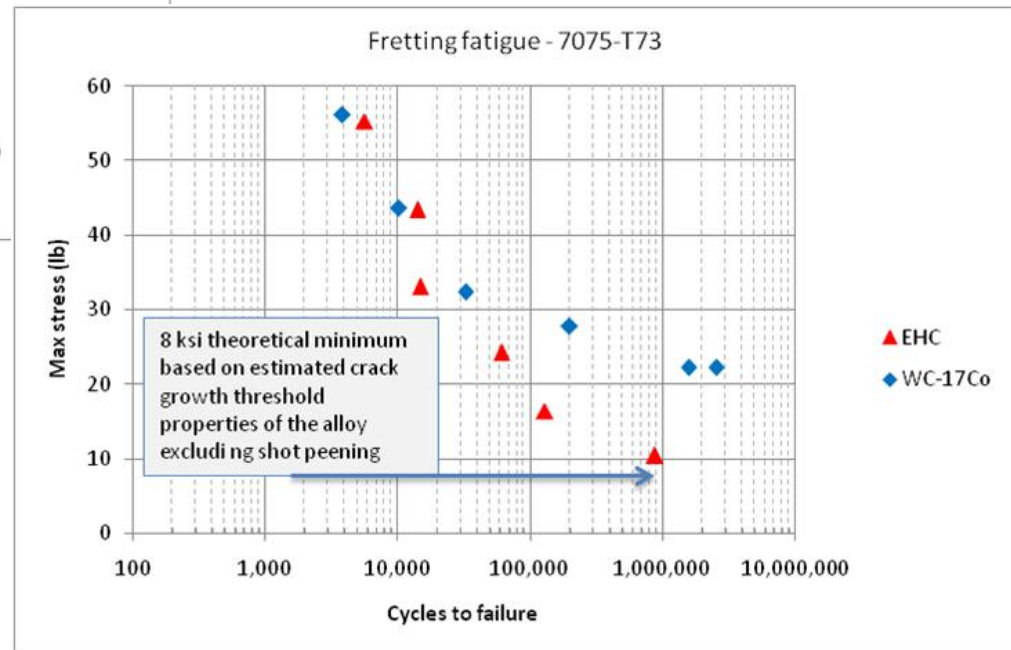
Fretting fatigue

In all cases HVOF WC-Co better than EHC
 Better wear, so slower to damage and initiate cracks

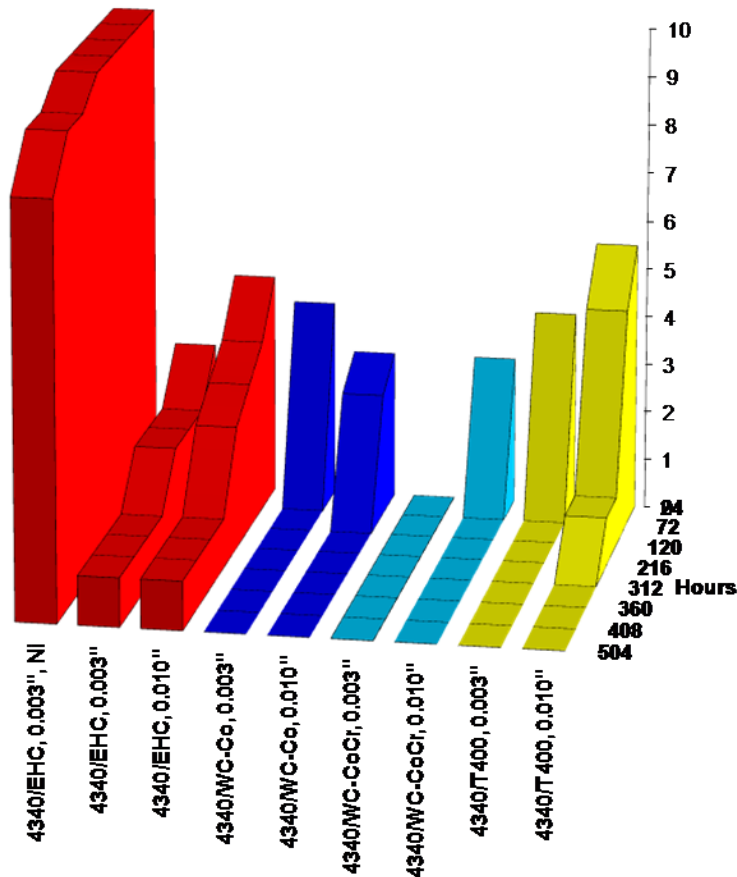
4340 Appearance number

Appearance rank – after clean at end of test

What does corrosion data mean?

□ Probably nothing

- Well-established that B117 salt fog tests have negative correlation with performance of HVOF vs EHC
- Service corrosion performance of HVOF usually much better than EHC
- G85 likely to be similar
 - Will not know for sure until shipboard exposure service test data are available

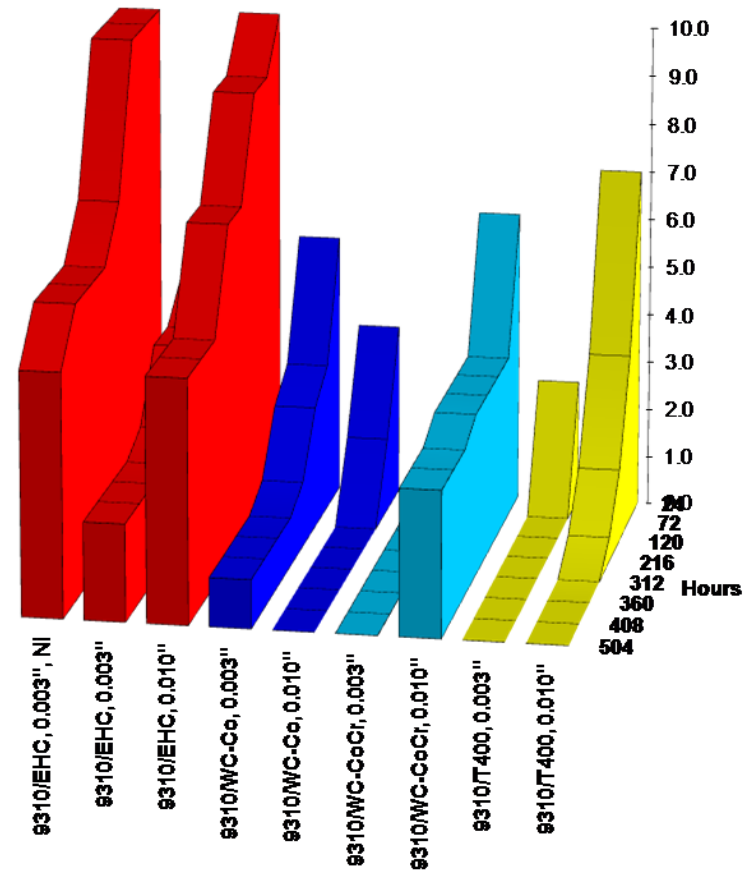
9310 Appearance number

Only EHC lasted the full 500hr

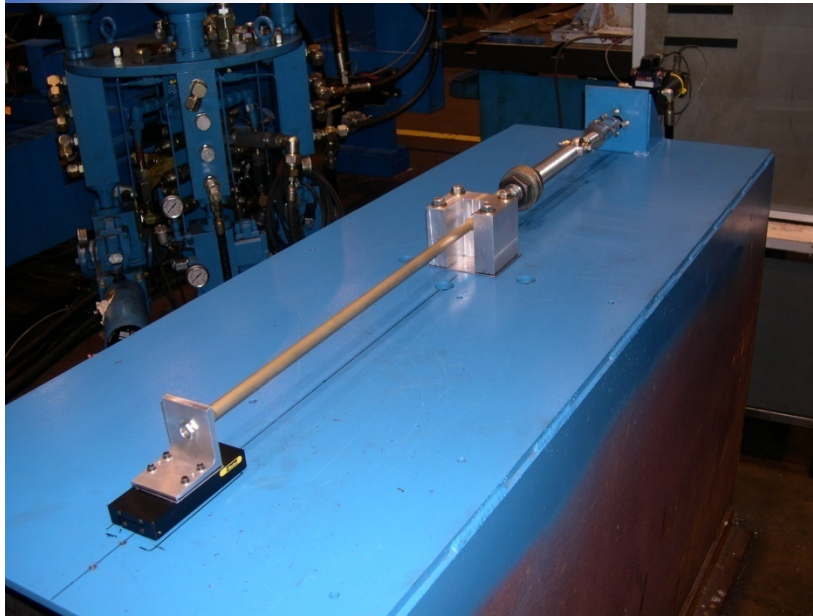
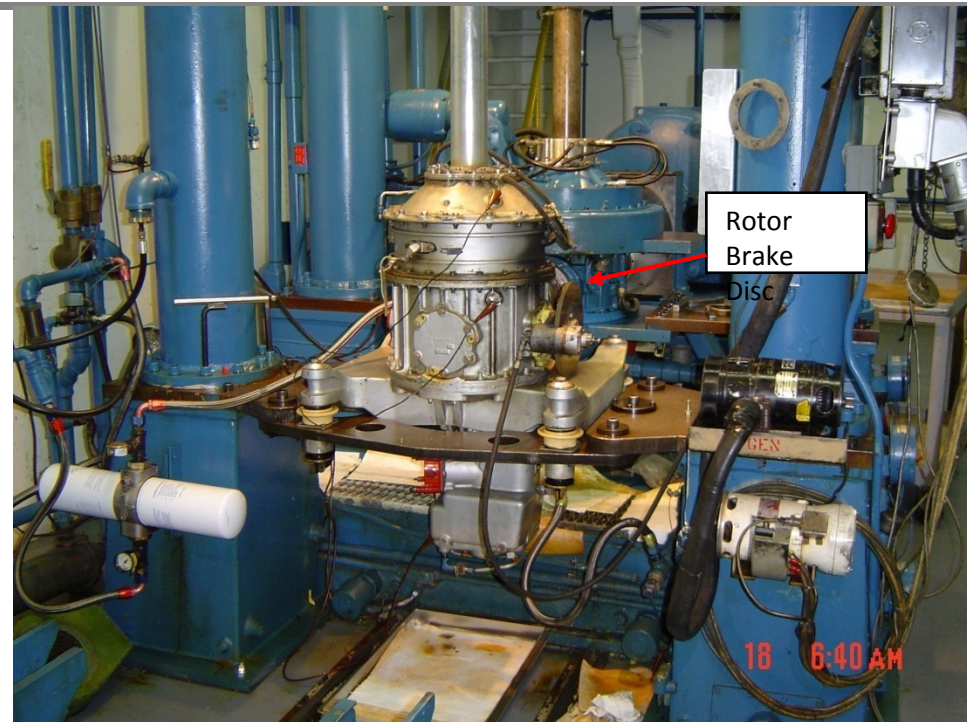
Bell Helicopter rig tests – WC-Co vs EHC

Tail Rotor Control Rod
Test included AZ road dust

Components qualified by tests

Flange, adapter rotor brake disc	UH-1
Flange, adapter rotor brake disc	AH-1
Spacer, tail rotor drive quill	UH-1, AH-1
Spacer, tail rotor drive quill	UH-1
Sleeve, Collective Scissors and Sleeve, Main Rotor Controls	UH-1H
No wear or leakage – performance of HVOF same as EHC or better

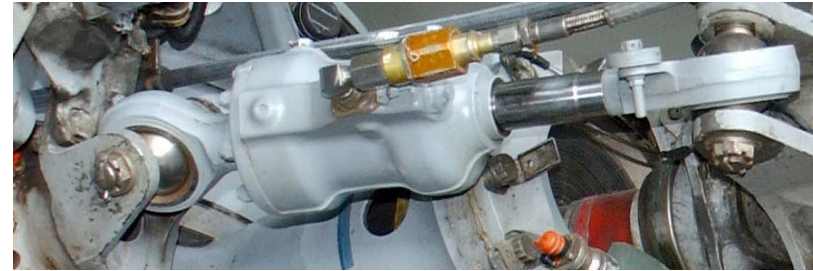
Lead-The-Fleet testing at FRC-E

- MRH Damper Current MTBR ~ 600 FH.

- Premature dynamic seal failure
- Caused by destructive wear particles from the Beryllium Copper bushing

- Improved seal designs, new coatings, stainless steel bushing coated in Katherm-87.
- Lead-the-Fleet Evaluation began FEB 2004.
